Stop your P76 Rusting Away

By Robert Hutcheon

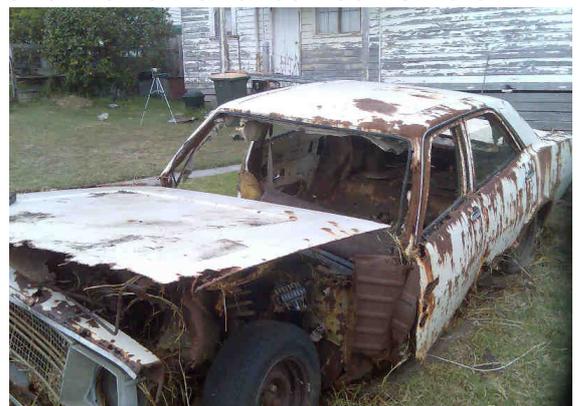
Don't let your P look like this!!
